# EXPERIMENTAL STUDY OF LOCAL BEHAVIOR OF STRENGTHENED REINFORCED CONCRETE SHORT CORBEL BY BONDING CARBON FIBER FABRICS

*Mohammed Ismail<sup>1</sup>, Dr. Mohhamed Ishaquddin<sup>2</sup>*

*NAWAB SHAH ALAM KHAN COLLEGE OF ENGINEERING & TECHNOLOGY NEW MALAKPET, HYDERABAD-500 024*

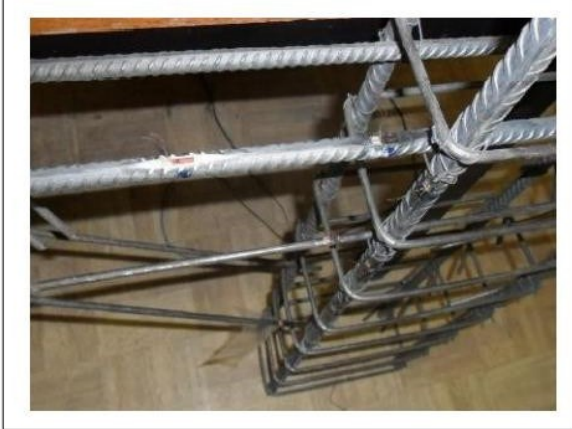
**Figure 2: Position of electric gauges on underwood of reinforced concrete corbel**

gauge factor 2.09. The strain gauges are attached to each of the experimental specimen. Precision strain gauges length of 5 mm (Figure 3) are used to measure the strain on the main steel reinforcement (Figure 2) as well as horizontal frame, steel tie rod placed along the tension and the compression strut. The strain gauges on the face of the corbel are placed in shear span between the corbel and the column. Two of gauges length of 10 mm are placed on the composite fibers plate surface and one gauge length of 30 mm on the concrete.

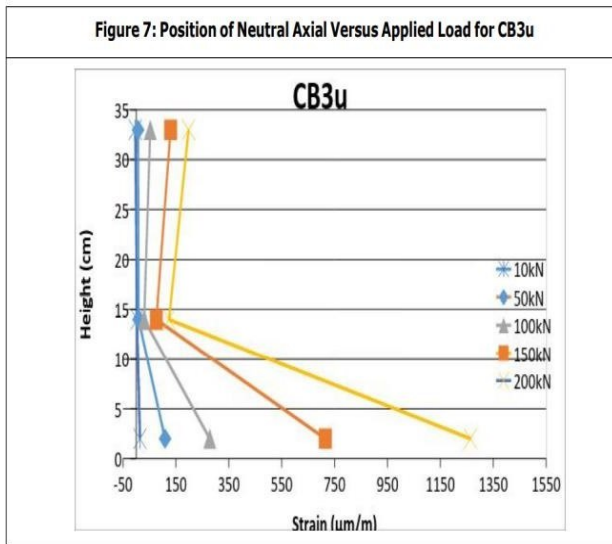
**Figure 7: Position of Neutral Axial Versus Applied Load for CB3u**

Concrete surface strains at a section close to column face of the tested corbels were measured by using three strain gauges over the depth of the corbel. Figures.6 and 7 show the concrete strain distribution over the corbel depth for all corbels at different load levels. In these figures, it can be seen that the strain distribution was approximately linear in tensile and compressive zones at low load levels, and then became increasingly nonlinear at the tension zone at higher loads due to cracking effect. For all tested corbels, the neutral axis was shifting upwards after increasing the load beyond than the load at first crack. The position of the neutral axis for small load (10 kN) is about 15 cm, for which reason the width of the plate is less than or equal to this value.

cross section appears linear. Beyond this value, the strain distribution is nonlinear as in Figure 6 and 7. Result show that strengthening by wrapping remains still best configuration. Effect of containment by wrapping provides higher values than those at which the plates are glued directly on the front breaking loads. Corbel CI2b the configuration presents a ductile behavior and avoids the sudden shear failure of unstrengthened reinforced concrete corbel. There are mainly three types of strengthened reinforced concrete corbel failures: flexion failure, shear and fabrics peeling off failure, compression failure with two diagonal cracks, figure 8. This article shows that it is possible to enhance or repair a reinforced concrete structure by bonding composite carbon fiber plate. This technique provides better stress distribution and implementation easier even if it requires careful preparation.

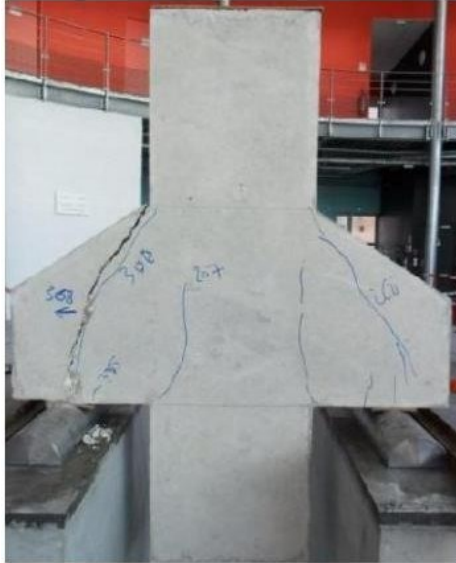
**a) C0 : Flexion failure**

The results, as shows in Figure 8(a), 8(b), 8(c) and 8(d), distinguished mainly three types of failure: flexion failure, shear and fabrics peeling off and compression failure. Although, CI2b and C0 were the same rupture, noted that cracking

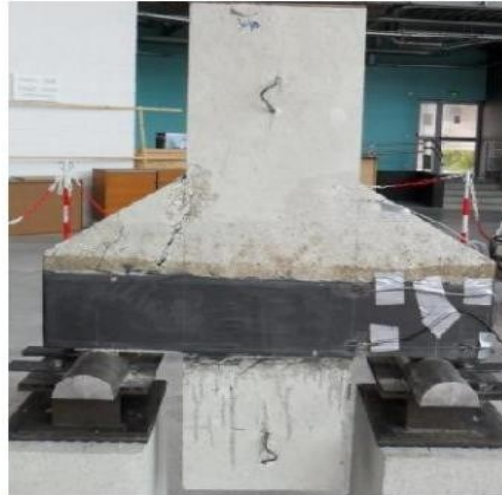
**b) CB3u : Compression failure**

First flexural cracks appear at 140 kN and then appearance of the bearing at 365 kN. Probably the appearance of diagonal cracks plays a lot because of the positive moment in after the landing. It shows the comparison of curves obtained by gauges "G1" (steel tie local deformation) for four different corbels. These curves are compared to reference reinforced concrete corbel without strengthening. The results show that curves are similar and ultimate load increases with a third reduction of deformation. The failure and crack patterns of the group strengthening with externally bonded one horizontal strip of fabric. In all four cases, first micro cracks is started at approximately the same load between 130 and 140 kN. There is one main diagonal shear crack almost at an angle 45 degrees and this crack is started at the bearing plate. This crack caused failure of the corbel. Corbel failed at ultimate loads at 651 kN.

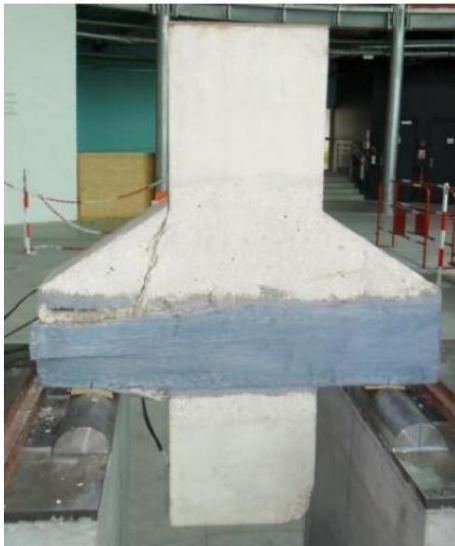
**c) CP3u : Shear collapse with fabrics peeling off**

This specimen was strengthened with externally bonded three horizontal fabric strips. There is only one major diagonal crack started at the bearing plate, and propagated towards the junction of the column and face of the corbel. This crack appears at a load of 310 kN and causes failure of the corbel. The corbel failed at an ultimate load of 380 kN. When the number of fabric strips is increased, the ultimate deformation of the corbel is caused by peeling off the strips of cloth. The accumulation of several strips of fabric on top of each other results in a thickening of the layer as a whole, and therefore, they peel off easily and cannot reach to the maximum load-bearing capacity of the composite. There was no apparent damage to the fabric, just concrete cracked major diagonal shear crack beneath the fabric. The concrete crack caused of debonded fabrics on the front and rear face of the corbel.

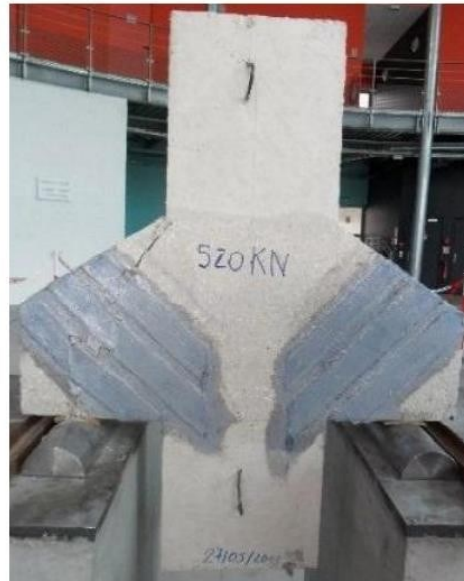
was different with appearance of a slight compression in CI2b.

First flexural cracks appear at 116 kN. As with the above specimen CP3u, there is only one major diagonal crack started at the bearing plate, and propagated towards the junction of the column and face of the corbel. This crack appears at a load of 380 kN and causes failure of the corbel. The corbel failed at an ultimate load of 520 kN. There was no apparent damage to the fabric, just concrete cracked major diagonal shear crack. The collapse of CI2b is appeared by Shear failure diagonal crack of CFRP fabric
