EXPERIMENTAL STUDY OF LOCAL BEHAVIOR OF STRENGTHENED REINFORCED CONCRETE SHORT CORBEL BY BONDING CARBON FIBER FABRICS

Mohammed Ismail¹, Dr.Mohammed Ishaquddin²

NAWAB SHAH ALAM KHAN COLLEGE OF ENGINEERING & TECHNOLOGY NEW MALAKPET HYDERABAD-500 024

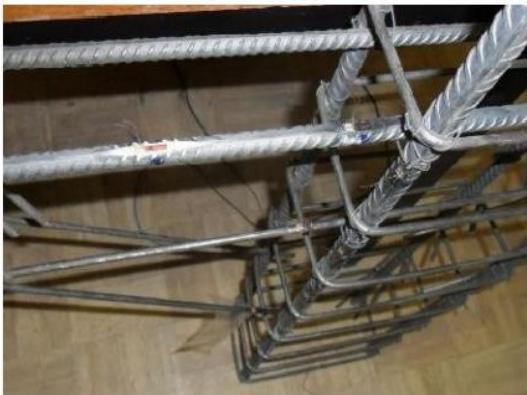
Figure 2: Position of electric gauges on underwood of reinforced concrete corbel

gauge factor 2.09. The strain gauges are attached to each of the experimental specimen. Precision strain gauges length of 5 mm (Figure 3) are used to measure the strain on the main steel reinforcement (Figure 2) as well as horizontal frame, steel tie rod placed along the tension and the compression strut. The strain gauges on the face of the corbel are placed in shear span between the corbel and the column. Two of gauges length of 10 mm are placed on the composite fibers plate surface and one gauge length of 30 mm on the concrete.

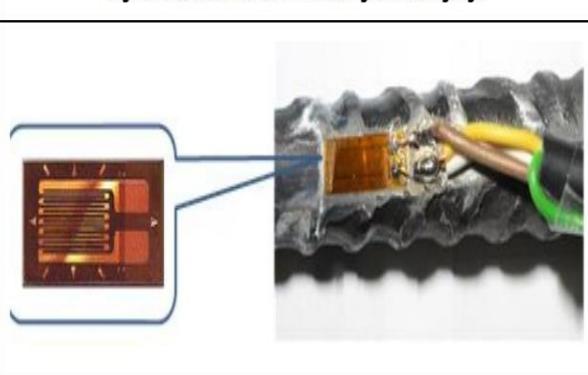
Figure 3: Detail of bonded and welding of electric gauge

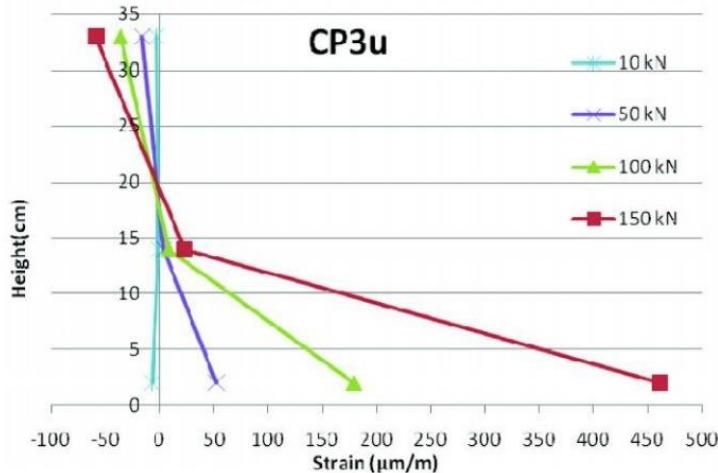
Figure 6: Position of Neutral Axial Versus Applied Load for CP3u

Concrete surface strains at a section close to column face of the tested corbels were measured by using three strain gauges over the depth of the corbel. Figures.6 and 7 show the concrete strain distribution over the corbel depth for all corbels at different load levels. In these figures, it can be seen that the strain distribution was approximately linear in tensile and compressive zones at low load levels, and then became increasingly nonlinear at the tension zone at higher loads due to cracking effect. For all tested corbels, the neutral axis was shifting upwards after increasing the load beyond than the load at first crack. The position of the neutral axis for small load (10 kN) is about 15 cm, for which reason the width of the plate is less than or equal to this value.

cross section appears linear. Beyond this value, the strain distribution is nonlinear as in Figure 6 and 7. Result show that strengthening by wrapping remains still best configuration. Effect of containment by wrapping provides higher values than those at which the plates are glued directly on the front breaking loads. Corbel CI2b the configuration presents a ductile behavior and avoids the sudden shear failure of unstrengthened reinforced concrete corbel. There are mainly three types of strengthened reinforced concrete corbel failures: flexion failure, shear and fabrics peeling off failure, compression failure with two diagonal cracks, figure 8. This article shows that it is possible to enhance or repair a reinforced concrete structure by bonding composite carbon fiber plate. This technique provides better stress distribution and implementation easier even if it requires careful preparation.

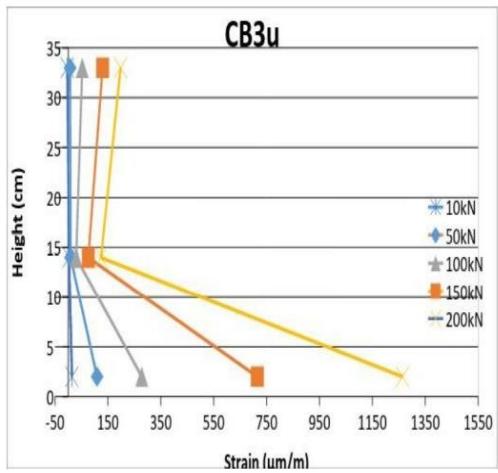
Figure 7: Position of Neutral Axial Versus Applied Load for CB3u

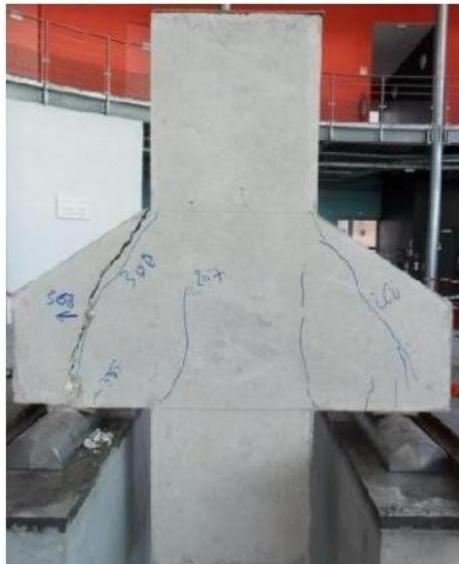
a) C0 : Flexion failure

The results, as shows in Figure 8(a), 8(b), 8(c) and 8(d), distinguished mainly three types of failure: flexion failure, shear and fabrics peeling off and compression failure. Although, CI2b and C0 were the same rupture, noted that cracking

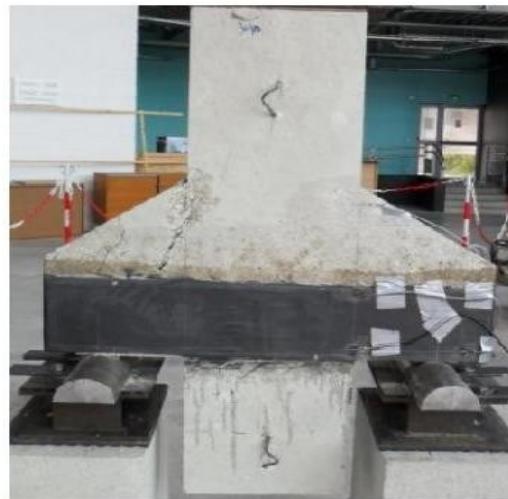
b) CB3u : Compression failure

First flexural cracks appear at 140 kN and then appearance of the bearing at 365 kN. Probably the appearance of diagonal cracks plays a lot because of the positive move in after the landing. It shows the comparison of curves obtained by gauges "G1" (steel tie local deformation) for four different corbels. These curves are compared to reference reinforced concrete corbel without strengthening. The results show that curves are similar and ultimate load increases with a third reduction of deformation. The failure and crack patterns of the group strengthening with externally bonded one horizontal strip of fabric. In all four cases, first micro cracks is started at approximately the same load between 130 and 140 kN. There is one main diagonal shear crack almost at an angel 45 degrees and this crack is started at the bearing plate. This crack caused failure of the corbel. Corbel failed at ultimate loads at 651 kN.

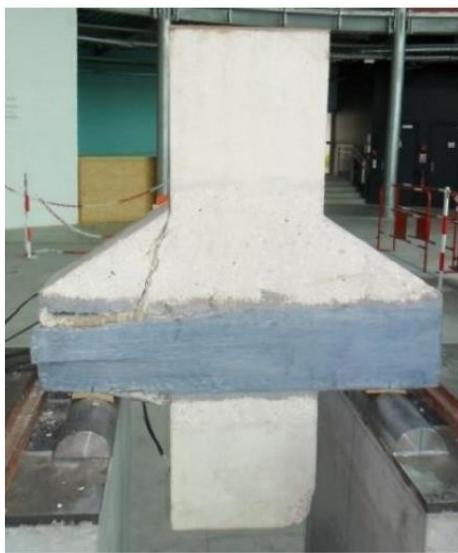
c) CP3u : Shear collapse with fabrics peeling off

This specimen was strengthened with externally bonded tree horizontal fabric strip. There is only one major diagonal crack started at the bearing plate, and propagated towards the junction of the column and face of the corbel. This crack appears at a load of 310 kN and causes failure of the corbel. The corbel failed at an ultimate load of 380 kN. When the number of fabric strips is increased, the ultimate deformation of the corbel is caused by peeling off the strips of cloth. The accumulation of several strips of fabric on top of each other results in a thickening of the layer as a whole, and therefore, they peel off easily and cannot reach to the maximum load-bearing capacity of the composite. There was no apparent damage to the fabric, just concrete cracked major diagonal shear crack beneath the fabric. The concrete crack caused of debonded fabrics on the front and rear face of the corbel.

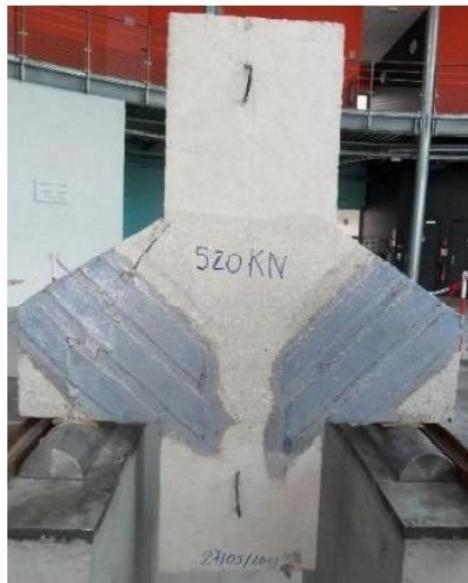
was different with appearance of a slight compression in CI2b.

First flexural cracks appear at 116 kN. As with the above specimen CP3u, there is only one major diagonal crack started at the bearing plate, and propagated towards the junction of the column and face of the corbel. This crack appears at a load of 380 kN and causes failure of the corbel. The corbel failed at an ultimate load of 520 kN. There was no apparent damage to the fabric, just concrete cracked major diagonal shear crack. The collapse of CI2b is appeared by Shear failure diagonal crack of CFRP fabric
